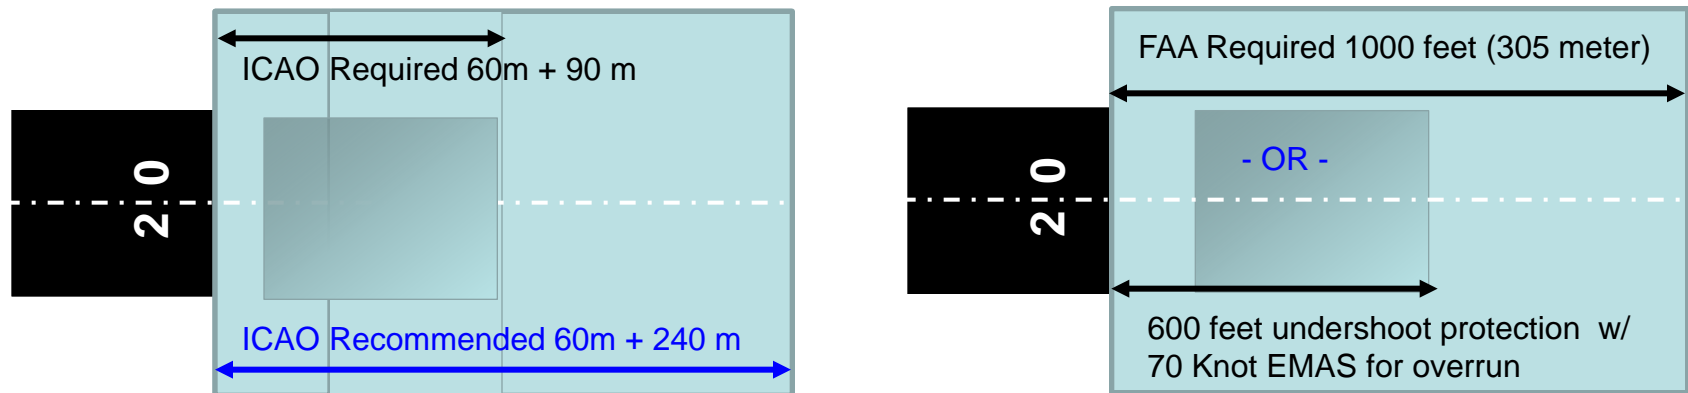
Runway End Safety Areas (RESA)

- Provides a safety margin for aircraft that overshoot the runway surface
- Dimensions dictated by International Civil Aviation Organization (ICAO) and State Civil Aviation Authorities

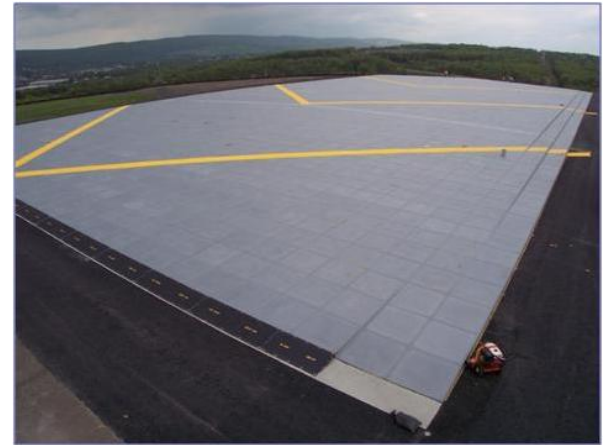
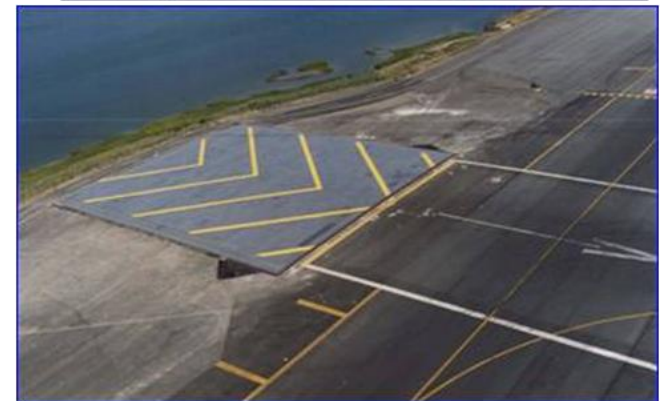
EMASMAX® - An Alternative to RESA

What is EMASMAX[®]?

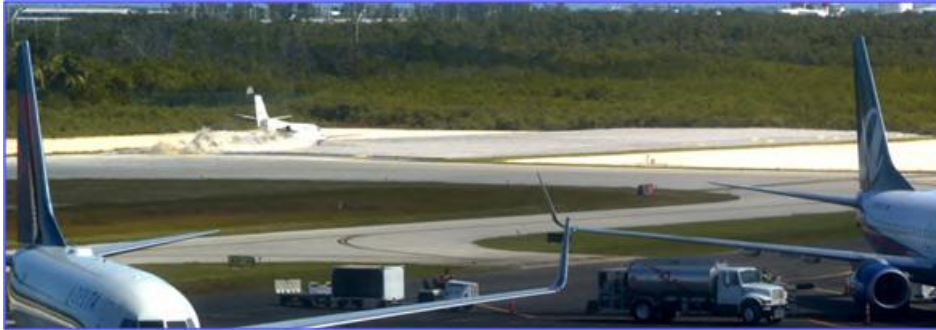
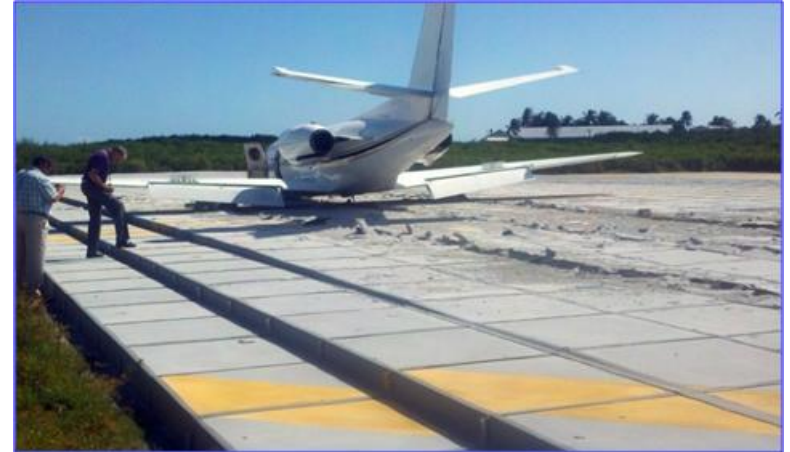
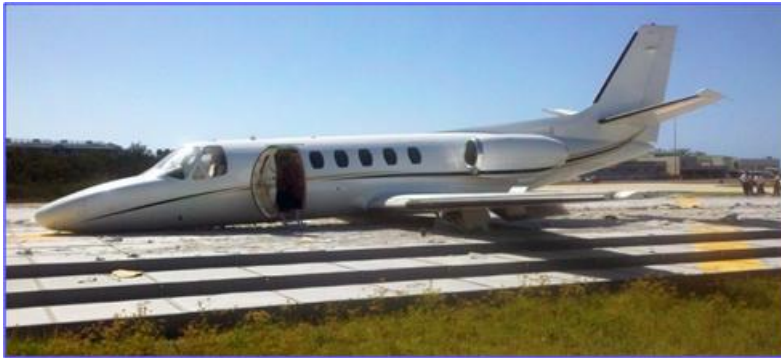
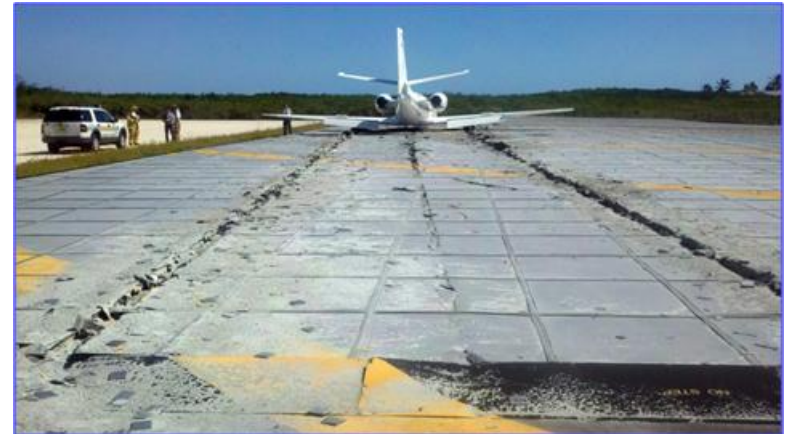
Key West (EYW) International Airport Arrestment

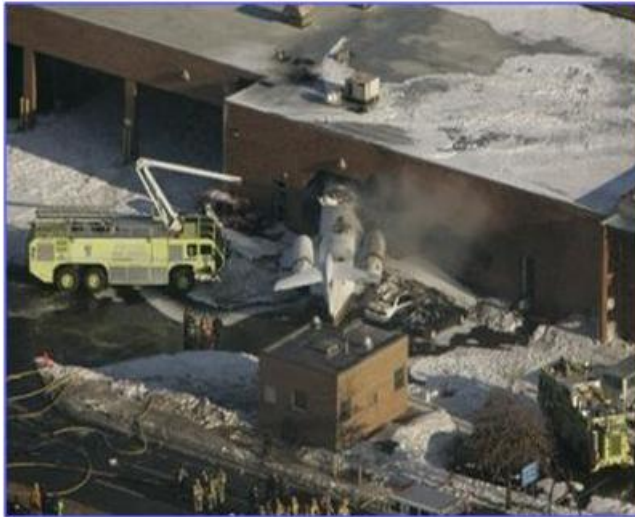
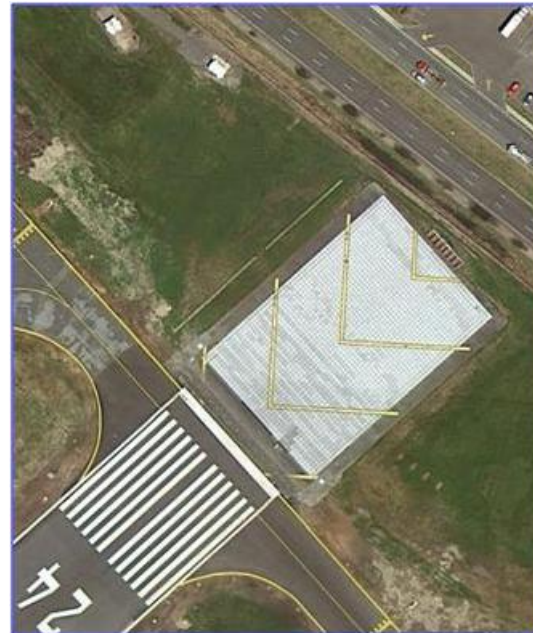
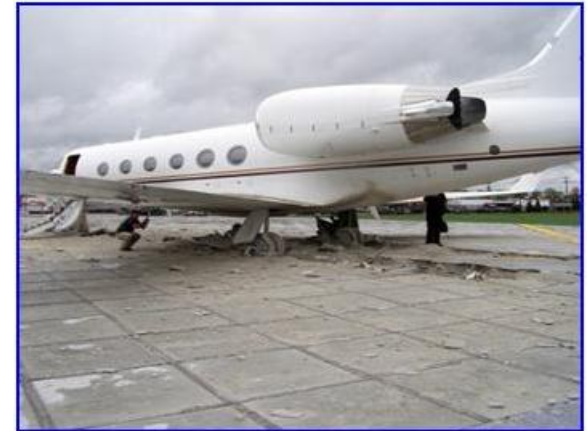
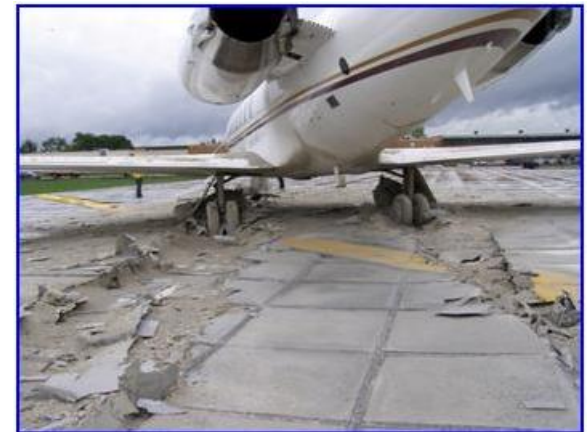
Photos Courtesy of Key West Int'l Airport

Teterboro Arrestment – October 2010

Teterboro, NJ Airport
Runway 06 Departure End

With EMAS - Arrestment
October 2010

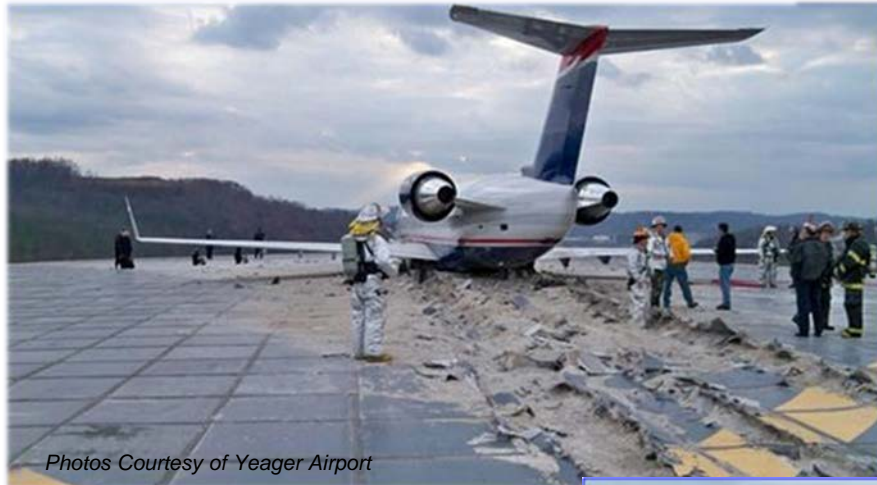
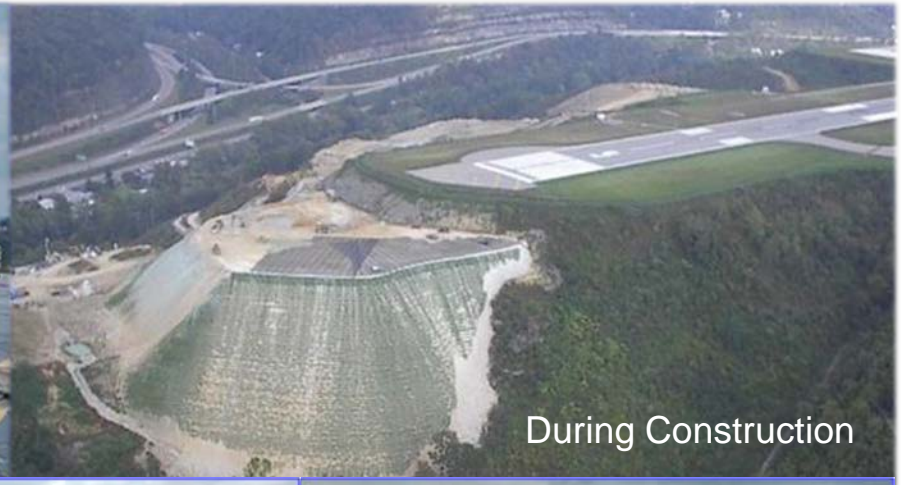
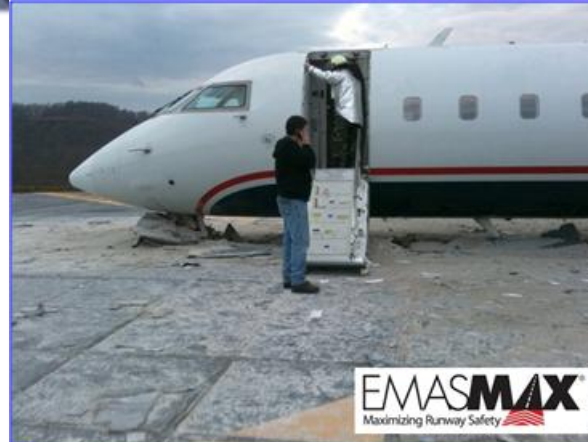
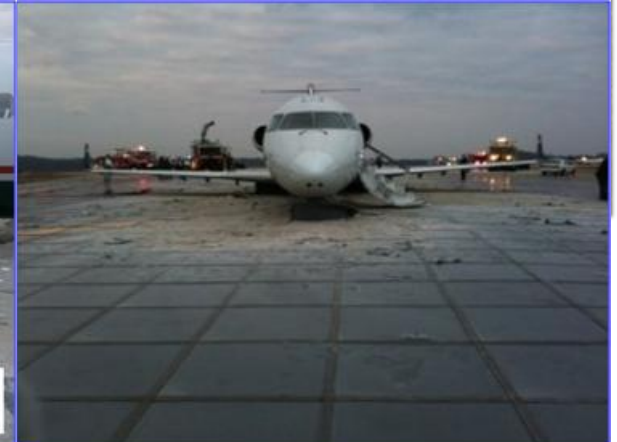
Above Photos Courtesy of Port Authority of NY & NJ

Charleston (CRW) Airport Arrestment

No injuries

Runway reopened just under 6 hours

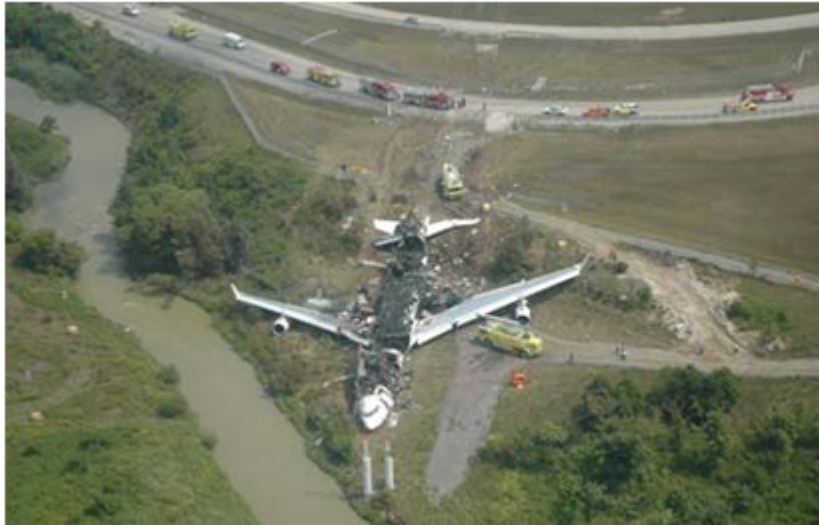
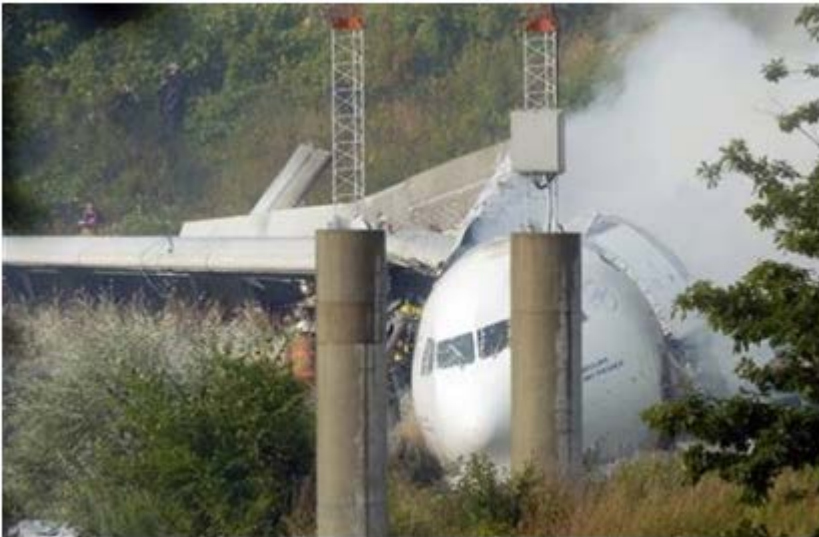
- TSB Final Accident Report
12 Dec 2007

“The Board believes that all such runways could benefit from a RESA built in accordance with the ICAO Annex 14 recommended practice or the FAA’s runway safety area (RSA) standard

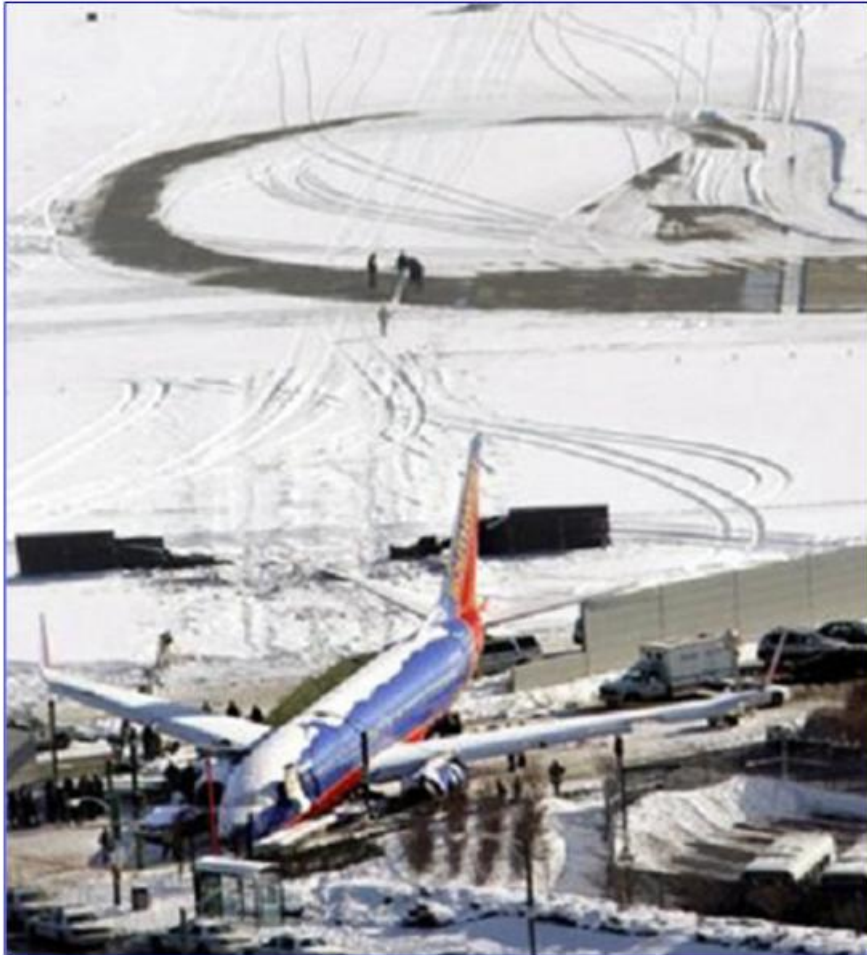
- NTSB Final Accident Report AAR-07-06
 - Findings Conclusion #23
